## Case 246 : Narrative

Case Vehicle (A): 1999 Ford	Vehicle (B): 1997 Ford	Vehicle (C): 1992 Mercury
Type: Taurus SE, 4-door sedan	Type: F150 XLT, 4x2 pickup	Type: Grand Marquis LS, 4-door sedan
Driver: 50-year-old female	Driver: Unknown	Driver: Unknown
CDC: 12-FDEW-3, 03-RFEW-2	CDC: 12-FDEW-3, 99-0000-0, 03-RBEW-2	CDC: 12-FYEW-2, 99-0000-0

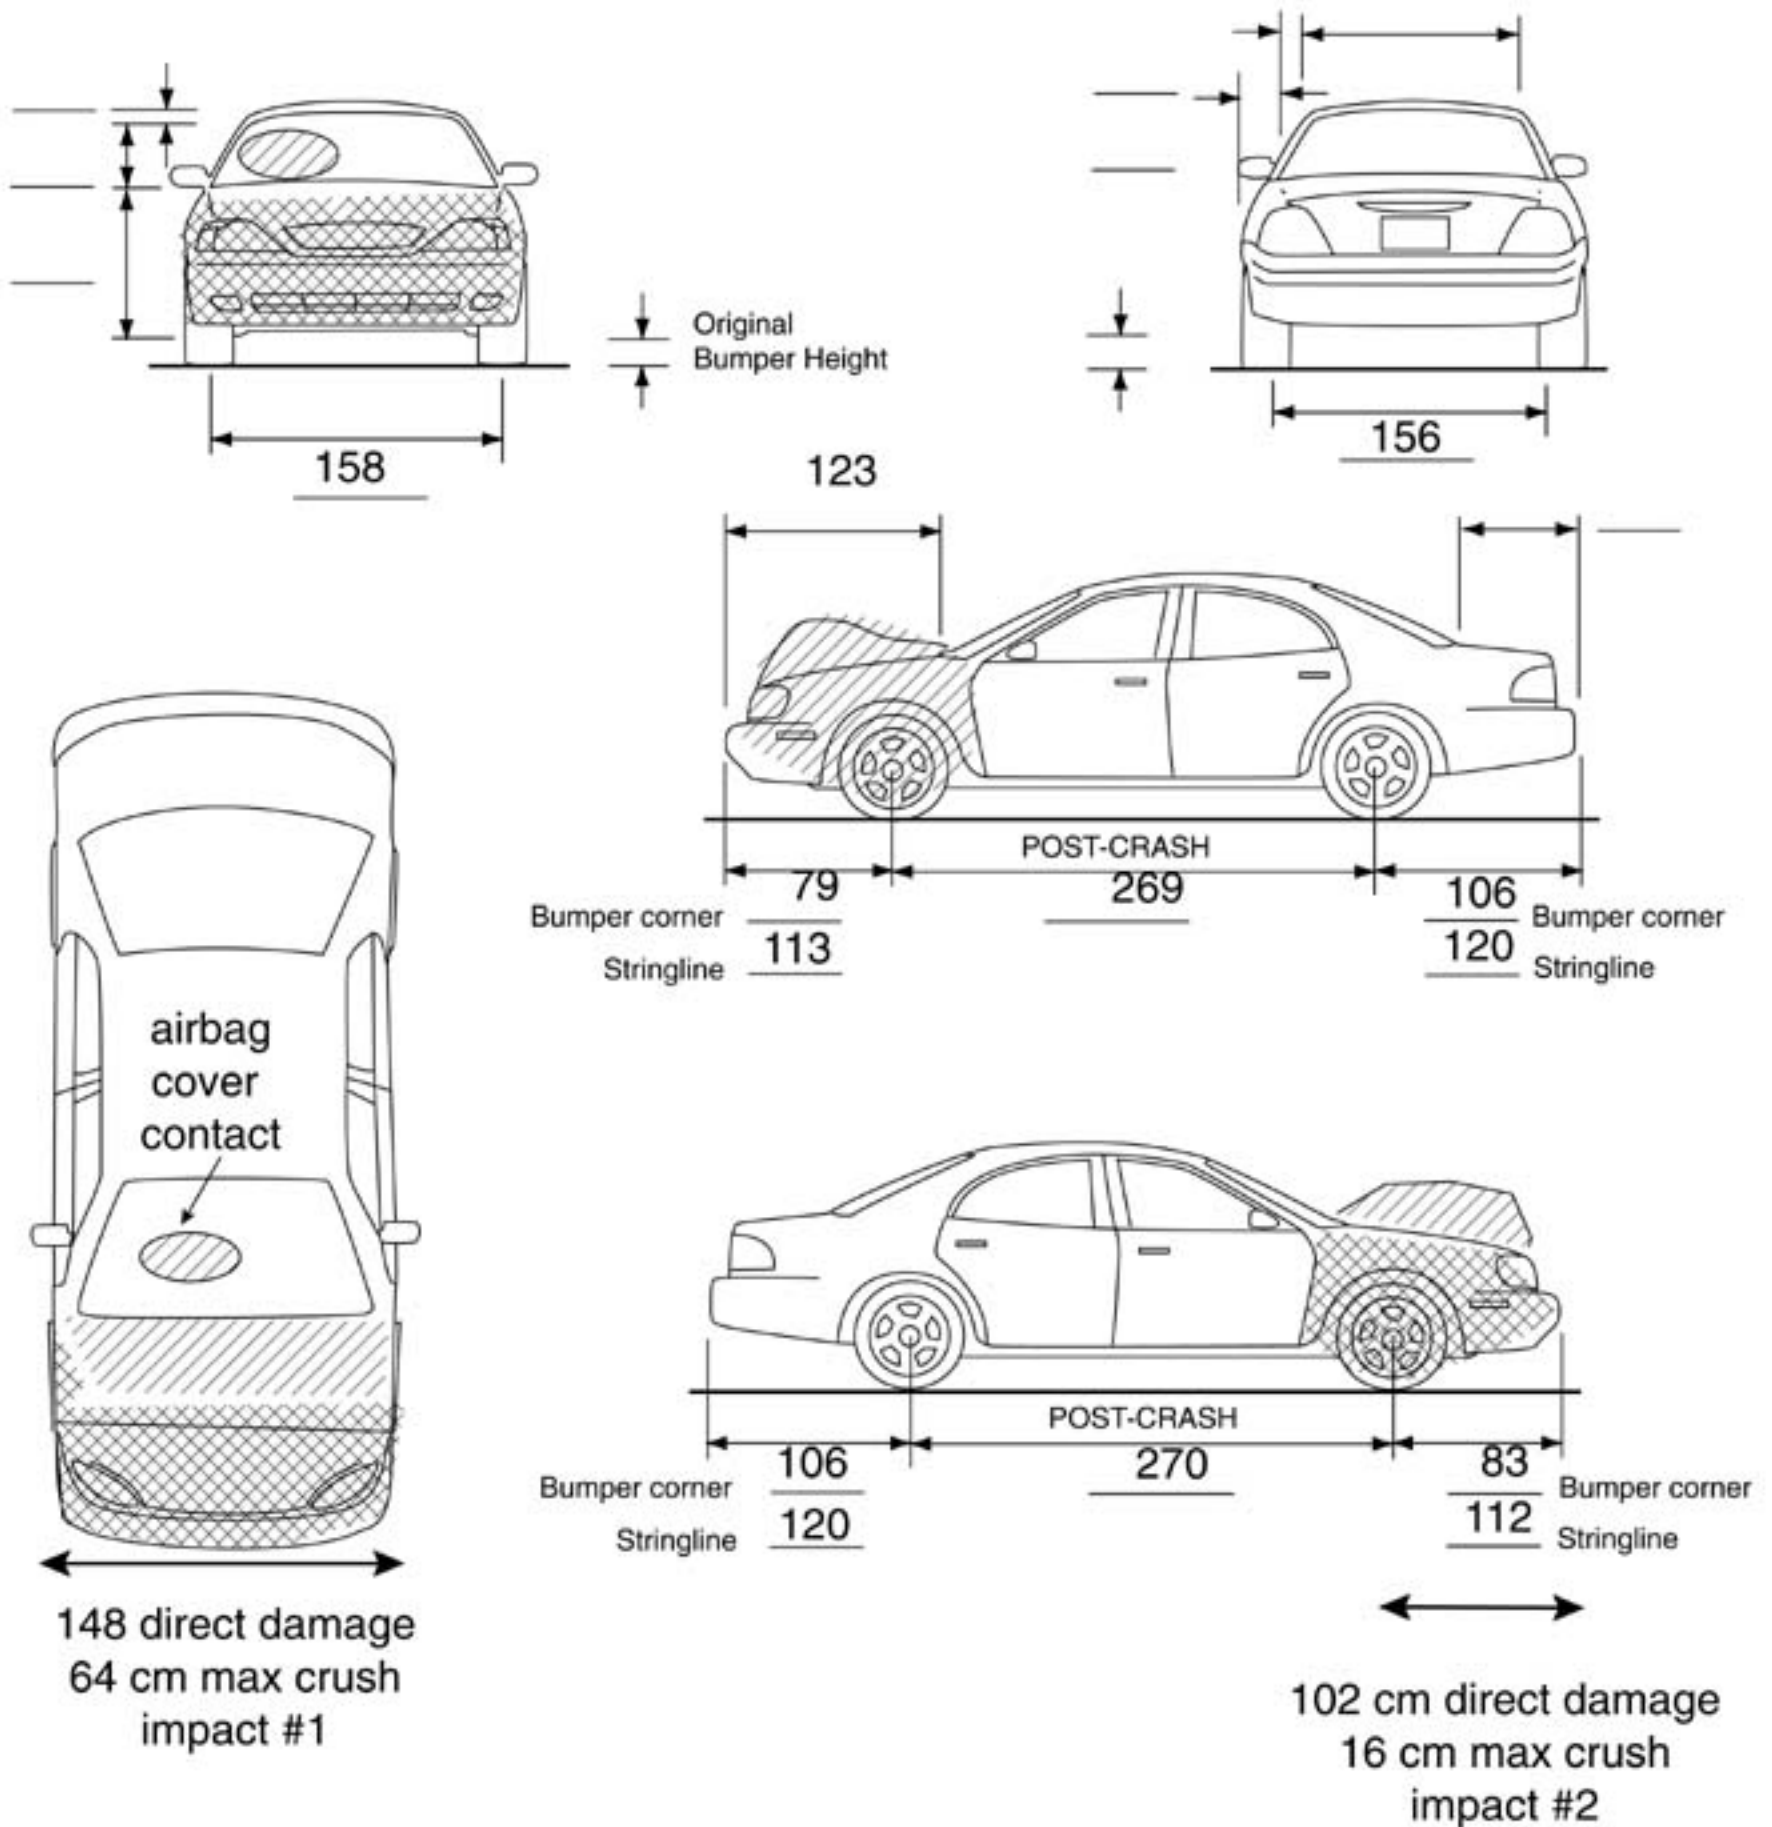
# MEASUREMENTS IN CENTIMETERS

161 cm direct damage  
26 cm max crush  
Impact #3

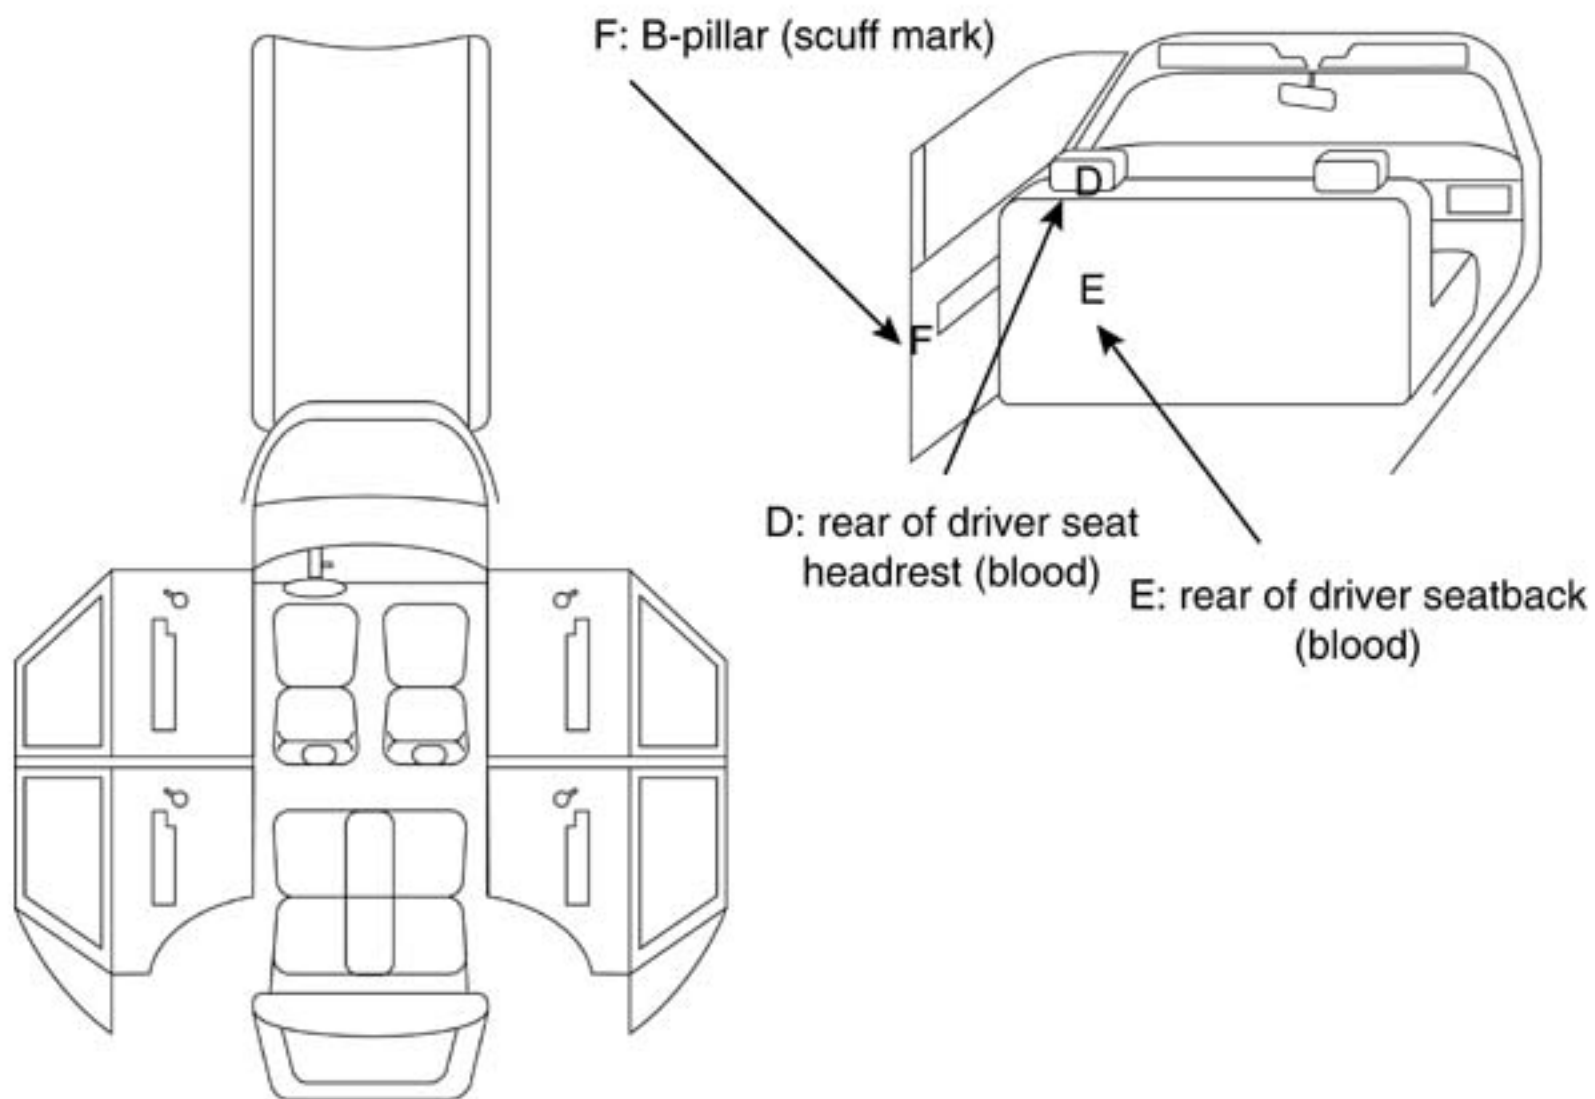
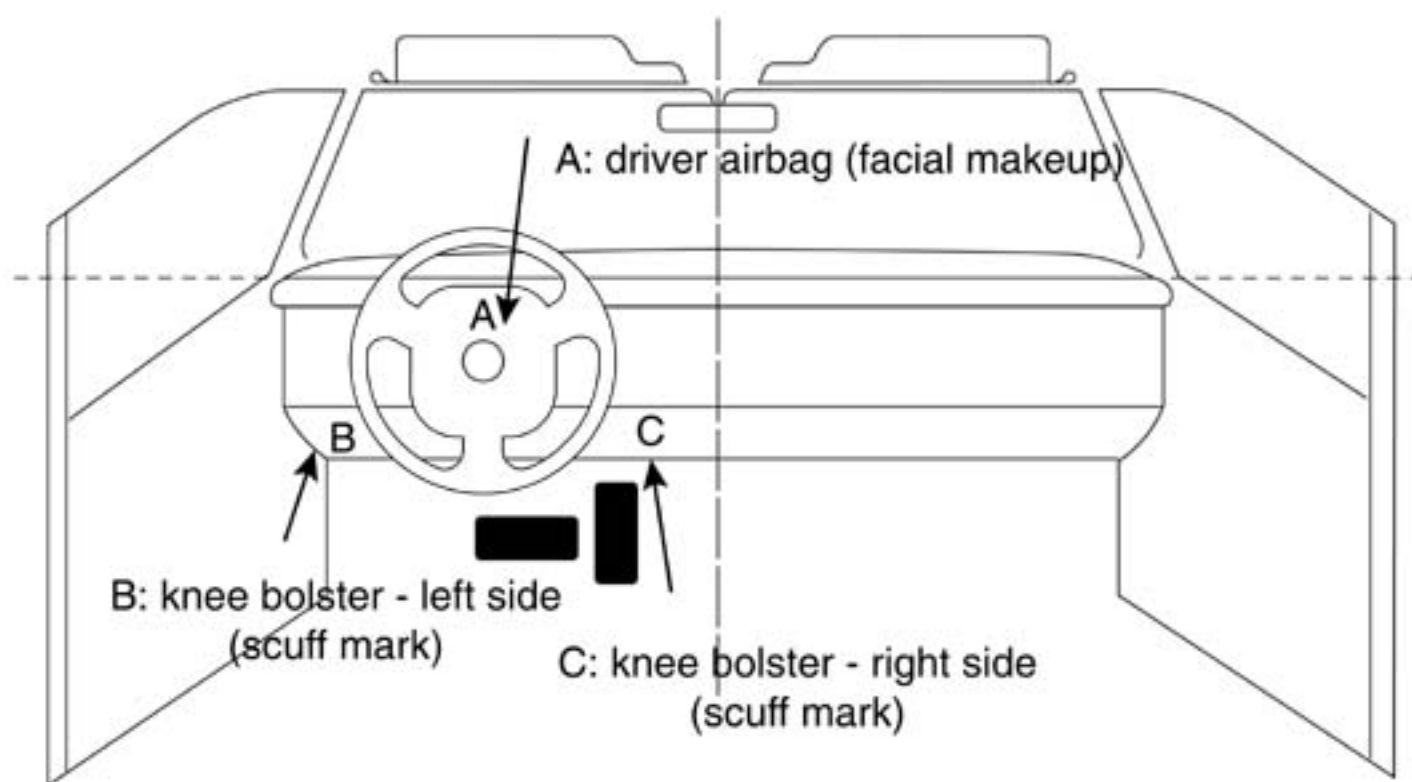
Driver Airbag

Contact	Interior Component Contacted	Occupant No. if Known	Body Region if Known	Supporting Physical Evidence	Confidence Level of Contact Point
A	Driver airbag	1	Face	Facial makeup	1
B	Knee bolster	1	Knee	Scuff and damage on left side	1
C	Knee bolster	1	Knee	Scuff and dent on right side	1
D	Rear of driver headrest	1	Head	Blood	2
E	Rear of driver seatback	1	Body	Blood	2
F	B-pillar	1	Head	Scuff mark	1
G
